FORTIFIED HOME™ - HURRICANE (2020)  
 FORTIFIED HOME™ - HIGH WIND (2020)

RE-ROOFING NEW SCAB MEMBER DETAIL FOR DAMAGED OR DETERIORATED WOOD FRAMING MEMBER

F-RR-2

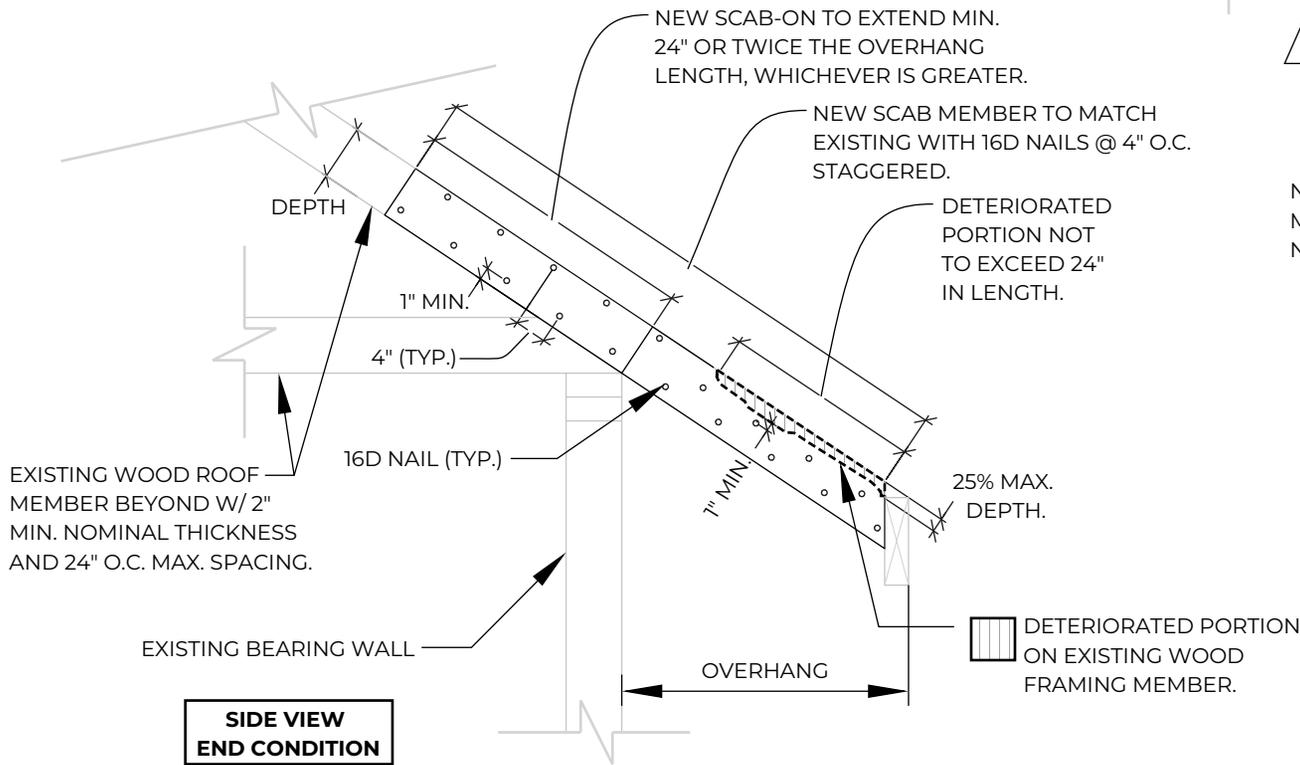
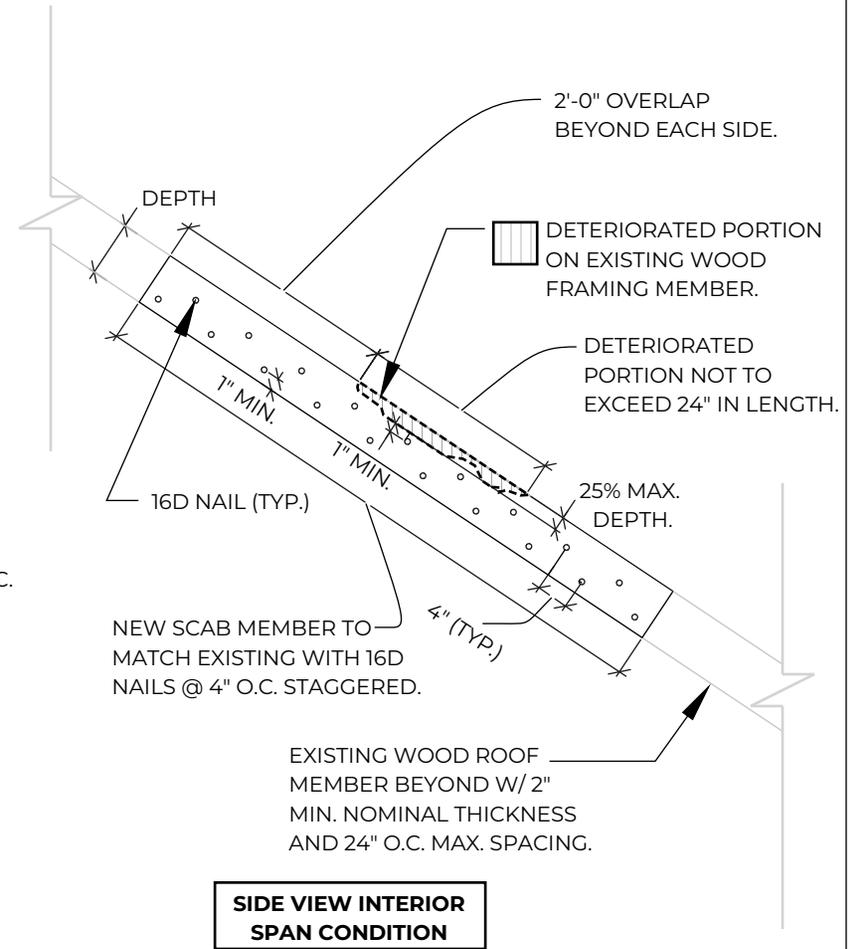
1. REFER TO APPLICABLE FORTIFIED HOME STANDARDS FOR ADDITIONAL INFORMATION.
2. SCAB WOOD MEMBERS MAY BE TRIMMED UP TO A MAXIMUM OF 1/2" AT THE BOTTOM TO FACILITATE INSTALLATION.

3. IF DAMAGE IS GREATER THAN THE CONDITIONS SHOWN, CONSULT A LICENSED PROFESSIONAL ENGINEER TO PROVIDE ENGINEERING DETAILS TO REPAIR THE DAMAGE.
4. DAMAGED/DETERIORATED AREA MUST BE A MINIMUM OF 6 IN. AWAY FROM ANY MECHANICAL CONNECTIONS (I.E. TRUSS/RAFTER HANGERS, TRUSS CONNECTOR PLATES, ETC.)

5. WHEN THE FASCIA OR SUB-FASCIA IS THE ROOF FRAMING MEMBER THAT IS DAMAGED OR DETERIORATED, REMOVE AND REPLACE THE DAMAGED/DETERIORATED SECTION PLUS AT LEAST 2 FT. BEYOND THAT SECTION ON EACH SIDE.
